Public Water System Annual Report

Town of Melita

2018

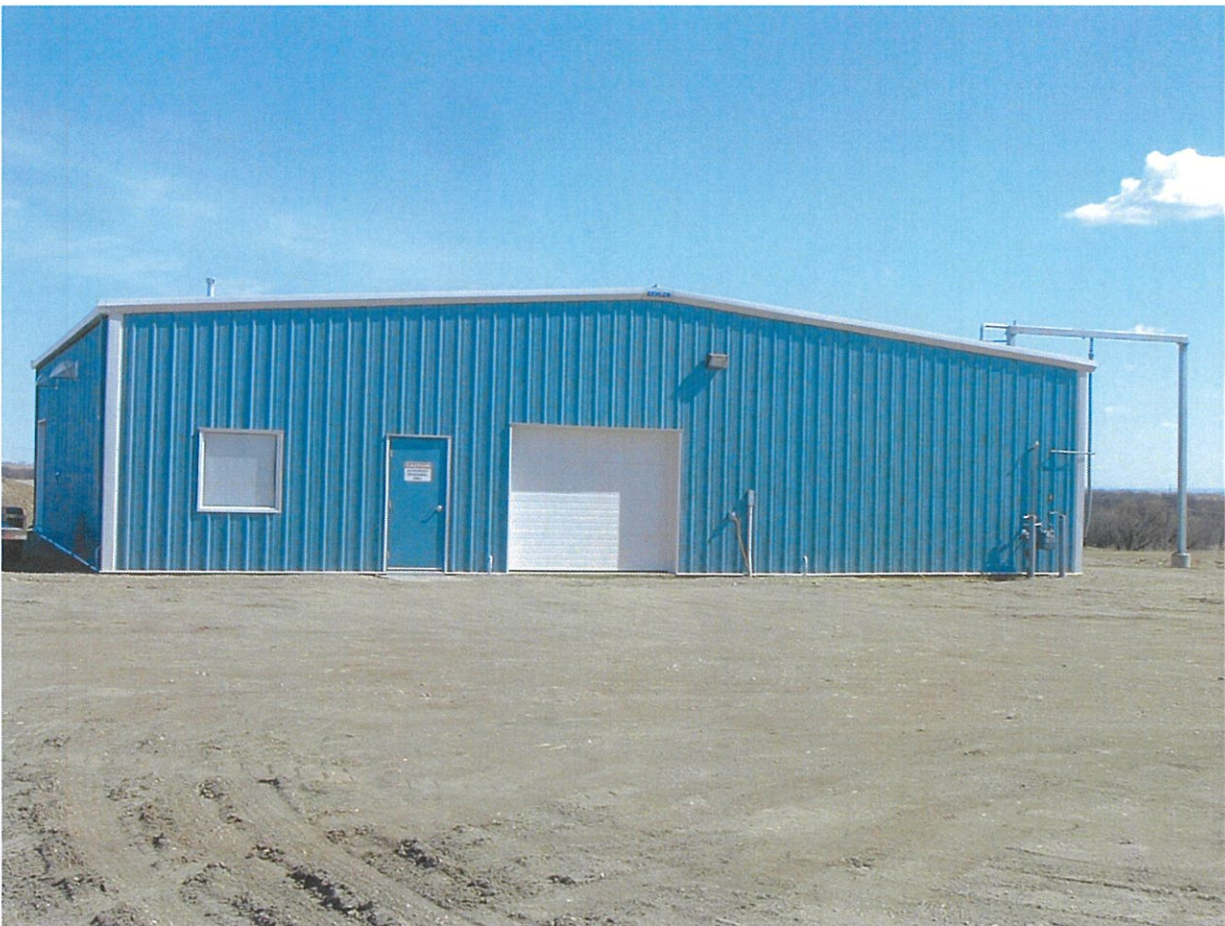
The Melita Water Treatment Plant

The Melita Public Water System (PWS) provides safe potable drinking water to the residents of Melita through the distribution system and to rural residents who aren't on the Co-op pipeline by means of the Truck Fill System at the Water Treatment Plant (WTP) and those who have lines coming off Melita's distribution system. Treated water produced from the WTP meets or exceeds all health and aesthetic objectives as stated in the *Guidelines for Canadian Drinking Water Quality*.

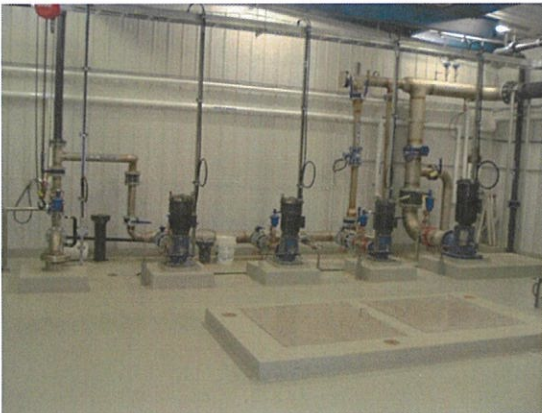
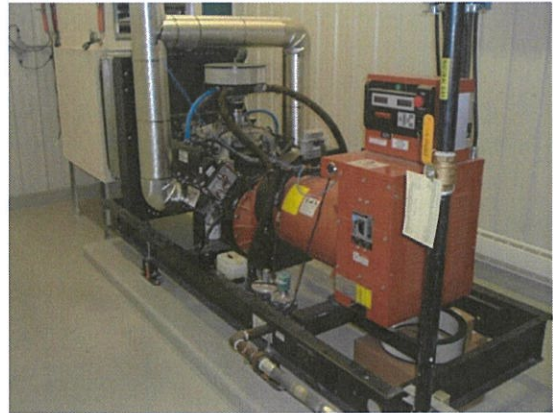
The Distribution Pumps

Treated water from the reservoir, located underneath the WTP, is pumped throughout the Melita distribution system via two 7.5 horsepower duty pumps, with one 30 horsepower emergency standby pump for firefighting purposes. The Town of Melita has 3 different types of pipe in its distribution system; they consist of PVC, cast iron and ductile iron, which all combined run for a total of about 15km. The WTP also has a natural gas powered generator located in the building that powers the distribution pumps during times of a power failure.
