Public Water System Annual Report

Southwest Regional Water Treatment Plant & Southwest Regional Water Co-op
2018

Date Prepared: 4/30/2018

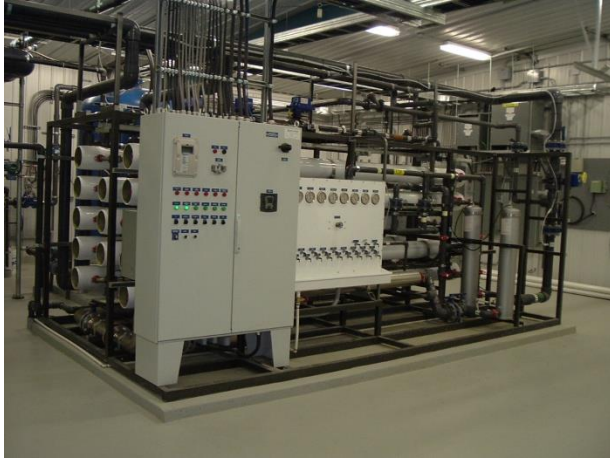
Raw water is pumped to the WTP where approximately 90% of the flow is directed through reverse osmosis membranes. The remaining 10% by-passes through a sand-filter with 3 new UV (ultraviolet) units prior to blending with membrane permeate. Blended flow is chlorinated with sodium hypochlorite and then stored in a 1,000,000-litre concrete reservoir for distribution. Since membranes remove most dissolved minerals, blending permeate with filter water allows the operation to produce treated water with a more desirable hardness and PH. Approximately 13% of membrane flow (11% of the raw water) is discharged as membrane concentrate to the Souris River. Treated water is distributed to the Co-op and a bulk water (truck) fill is available for rural usage. In the spring of 2014 the second RO unit and filter came online doubling the production capacity of the plant.

The South RO (original unit)

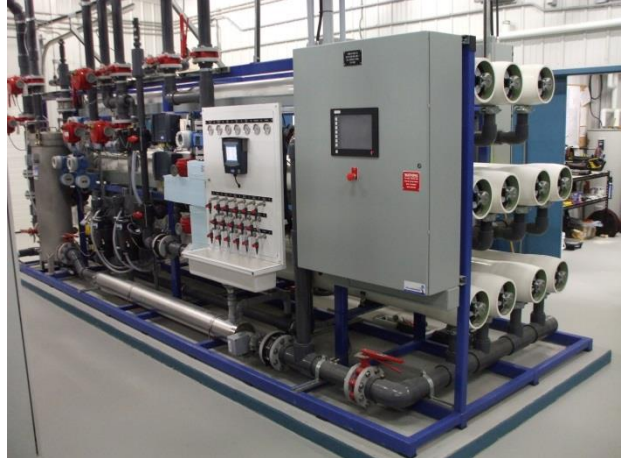
The North RO (new)

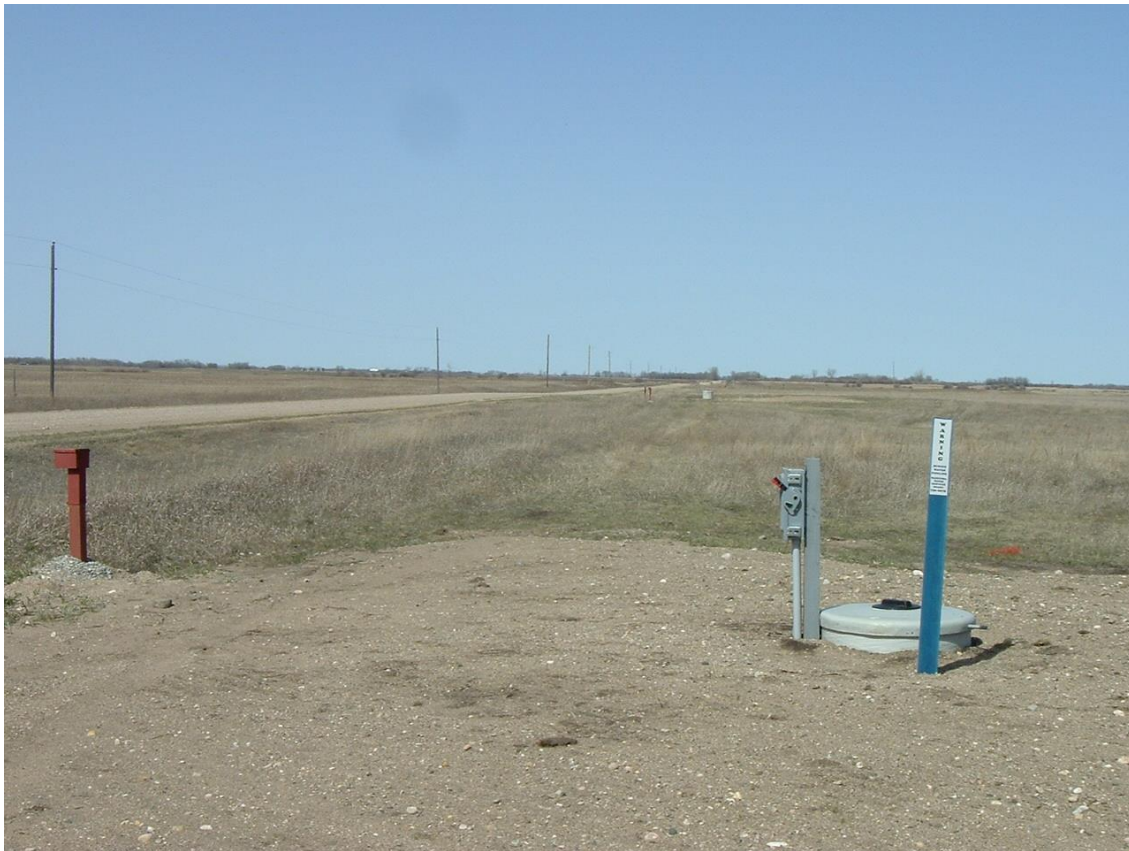
Recharge Wells

Since the middle basin could only be pumped intermittently, the north basin well was temporarily equipped with a pump, generator, and overland pipeline to speed up the water table recovery. Pumping from this basin occurred from September 3rd to September 21st until water levels significantly recovered and the north basin water table prevented further pumping. The water table in the north basin has since recovered. In 2012 the north basin was converted to a supplemental well to improve operating pressures and flows to the plant when it is in operation.

Since fall of 2017 we have not had to recharge the east site because we stopped pulling water from these wells and now only pull from the new ones at the East site.

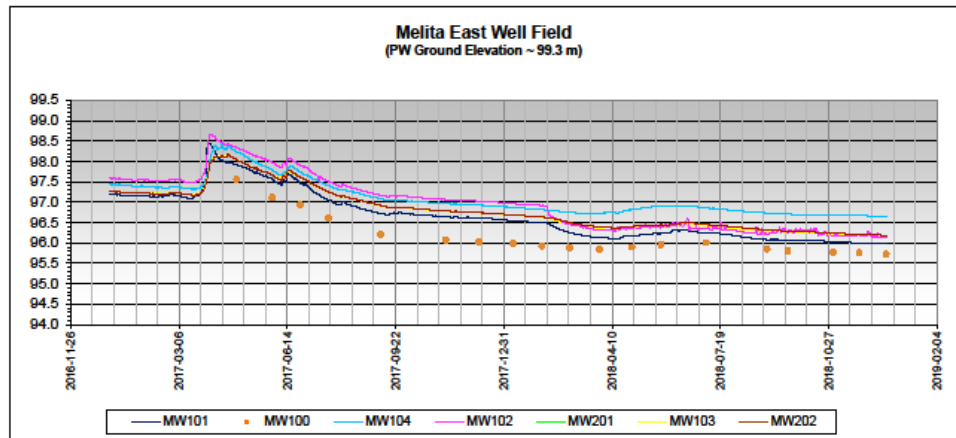
Groundwater monitoring commenced in July 2009. As many as four pressure transducers were initially set-up and currently three pressure transducers are continuous and manual readings. This graph uses a benchmark of 100.00 m in order to compare levels in each the three basins.

The locations of all monitoring wells are shown in the appendices. 5" MW represents the water table depth near the production well, while MWa and MWb represent the water table depth in the middle and north basins.

The updated graph on page 11 shows ground water levels at various points at and around the new wells.

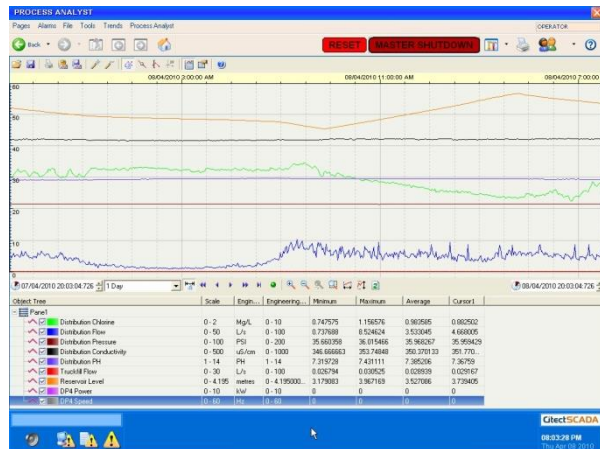
The WTP is monitored continuously by the computer system; it is continuously taking readings from 85 different locations by sensors, probes, and meters. This information is displayed in real-time on a different number of screens (*see Figure A, B, C which show three different computer screens*) and is also recorded and compiled in the form of a trend. These trends can

be accessed at any time and show a history of plant operation in various areas (see Figure D for an example of a trend screen).

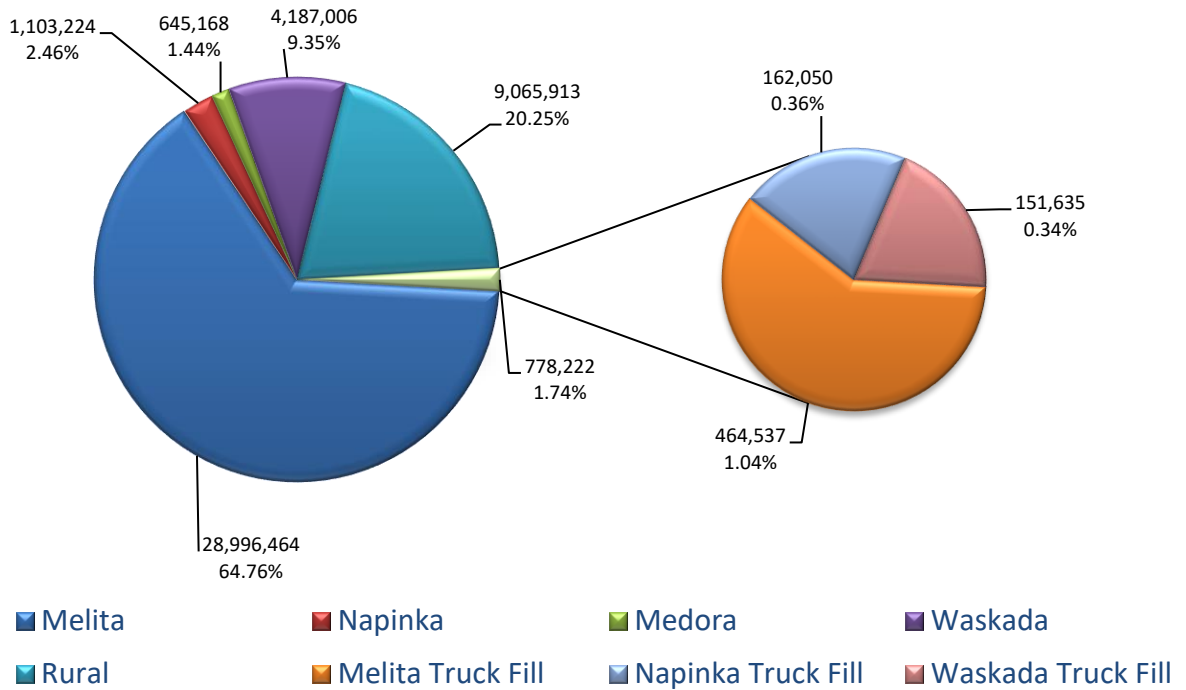
2018 Usage Chart in Imperial Gallons

The treatment system capacity was designed to meet a 20-year future demand for Melita as well as additional capacity for the rural water system. The water system production and usage are summarized in the following charts in ***Appendix "A" – Usage Charts.***
